## EXPERIMENTAL INVESTIGATION AND FINITE ELEMENT MODELLING OF MICROSTRUCTURAL COMPOSITE MATERIAL

H.A. Cayzac<sup>1\*</sup>, L. Laiarinandrasana<sup>1</sup>, S. Joannes<sup>1</sup>

<sup>1</sup>Mines Paristech, Centre des Matériaux, CNRS UMR 7633, BP 87, 91003 Evry Cedex, France

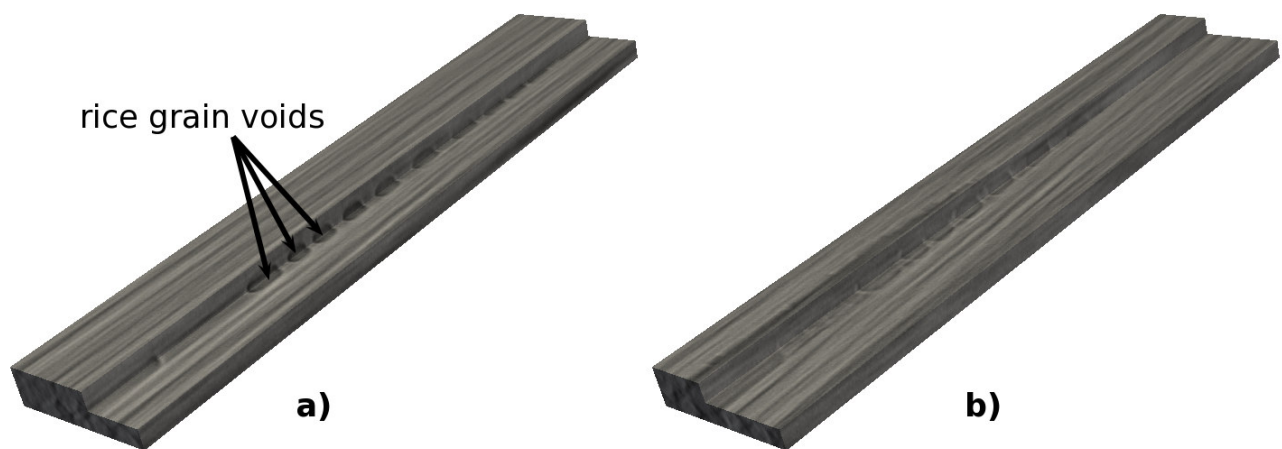
Laminography experiments [2] were set up on bands of 1.5 mm thick. Specimens were notched either in the longitudinal direction or in the transverse one. Initiation and propagation of cracks are due to a device allowing a displacement between the two edges of the notch [2]. The experiment consists in scanning the initial microstructure, applying a displacement between the notch edges in order to propagate cracks, scanning the microstructure and so on up to the total failure of the specimen. Therefore in situ damage can be characterized in transverse and longitudinal directions.

**Figure 3.** X-ray tomography images. (a) Initial microstructure with voids; (b) Microstructure after deformation: void growth.

Initial scans corresponding to undamaged material were assessed with the help of SEM inspections. Indeed voids exhibit "rice grain" shape and dimension along fibres can be much higher than diametrical dimensions. Whatever the implantation of the notch, parallel or perpendicular to the fibre direction, the main crack always propagates through the matrix in the fibre direction due to the high isotropy of the material. Fig.3(a) represents initial voids in the composite material. This volume is located far from the notch root. These voids are probably due to a lack of matrix polymer between fibres. Fig.3(b) shows the same volume after deformation of the sample. Voids have clearly grown and are likely to coalesce to lead to a cylindrical crack. The space between voids gets smaller, thin polymer walls are separating voids. It is assumed that damage mechanism in the matrix under such sollicitation is based on void growth.
